POPPLETON HISTORIC STUDY

B-2763

<u>Block</u>	<u>Lot</u>	<u>Address</u>	MAGI #0427635404
253	54-57	104-116 Parkin Street

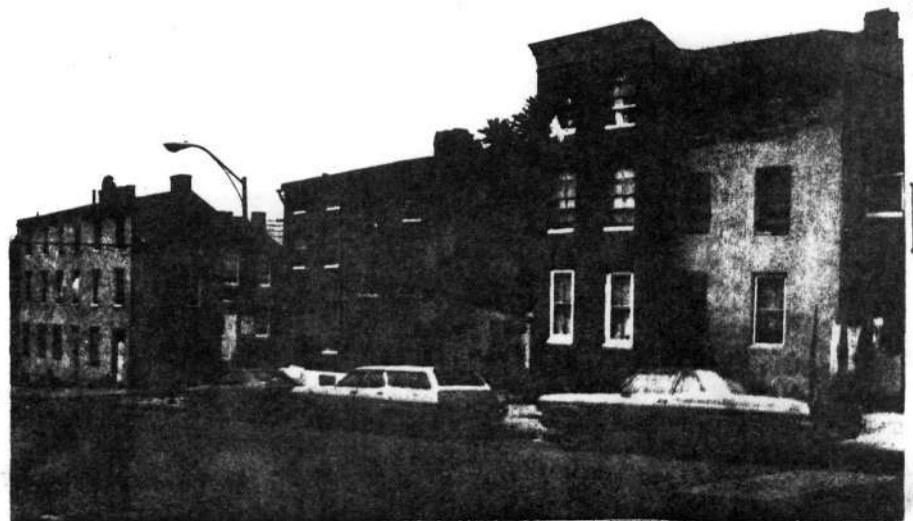
116 114      110 108      104/106      104

The deed on 114-116 was checked; the date of the building is 1849. Numbers 110-108 are shed roofs and are quite early. House with cornice has no street number or door; must be part of lot 54 ( call it 106). Number 104 is an old shed roof, a form that shows up frequently in the 1868 Sachse views.

This is a curious group because of the shape of the lots. This is one of few cases where lots were made shallow (14'-16') on the major street frontage.

Number 108 is vacant and although there are no gaps from demolition of buildings, the terrace has little or no continuity due to intervening streets, alleys and separation of houses. Nevertheless, there is a particular interest here in the uniqueness of architectural form. The sidewalk is unusually wide and in need of repair; street trees are sorely needed.
